Hidden Failure Analysis

Three Invisible Root Causes Behind Intermittent Connector Failure

A Technical Dossier on Sub-Surface Failures

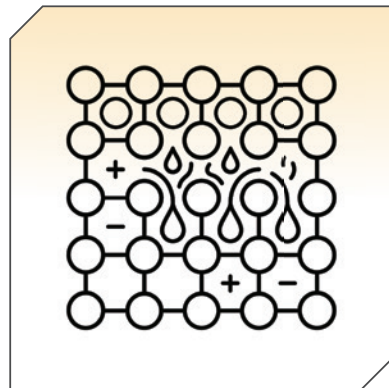
THE MICRO-BATTERY

Galvanic Porosity

Galvanic porosity occurs when corrosive electrolytes penetrate gold plating through microscopic pores. In humid environments, moisture reacts with the underlying copper base, creating a galvanic cell. This reaction forces corrosion products to the surface, appearing as tiny green or black spots on pins, which ultimately compromises electrical conductivity and performance.

MANAGING THE MICRO-BATTERY

The Symptom

Tiny green or black spots appearing on pins, specifically in humid environments.

If the gold layer has microscopic holes (pores), humidity creates a conductive path to the base metal.

Gold = Cathode
Copper = Anode
Humidity = Electrolyte

Increasing gold thickness is the expensive fix. The smart fix is surface prep.

Electropolishing and leveling brighteners.

Pores often start as microscopic peaks and valleys in the raw stamped metal. We use leveling brighteners in the Nickel activation state to smoothen the substrate.
